FACE INVESTIGATION

SUBJECT: Farmer Dies When Skid Steer Loader Overturns

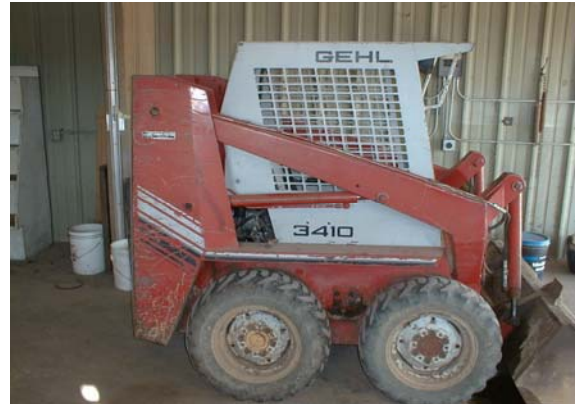
Figure 1. Side view of skid steer loader

SUMMARY: A male farmer (the victim) died when the skid steer loader he was operating overturned in a field on his farm (Figure 1). The victim was apparently planning to move a pile of stones on a hill. When he drove the loader uphill with the bucket raised in a high position, the loader tipped over backwards. The restraint bar on the loader was lowered, but the seatbelt was unfastened at the time of the incident. The victim struck his head on the back of the loader cage when the machine overturned, and he lost consciousness.

It was the victim's custom to drive the loader with the bucket raised high, to have a better view in front of the loader. He apparently drove the loader uphill with the bucket raised to its maximum height, which caused the loader to tip backwards.

Discussion: A skid steer loader may tip toward the heavy end of the machine when traveling on a slope. In this case, the heavy end of the loader was the rear, where the counterweights were located. When the victim drove uphill, the weight on the rear of the machine caused it to tip backwards.

Recommendation #2: Farmers who use skid steer loaders should travel and turn with the bucket in the lowest position possible.

Discussion: A loader is more likely to tip when the when the bucket is raised because the center of gravity is higher. The operator should keep the bucket as low as possible when traveling or turning, and raise the bucket only as high as necessary when the machine is not traveling.

Recommendation \$3: Farmers who use skid steer loaders should travel straight up or down hills with the heavy end of the machine pointed uphill.

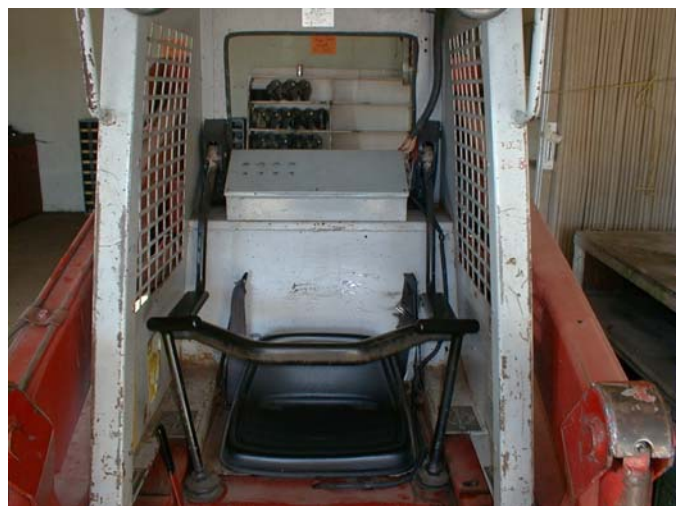
Figure 2. View of cab with seatbelts and restraint bar.

The restraint bar on the loader was lowered, but the seatbelt was unfastened at the time of the incident. The victim struck his head on the back of the loader cage when the machine overturned, and he lost consciousness. His position in the cab caused his airway to be closed off, so he was unable to breathe. A family member who was working in an adjacent field found the overturned loader, with the victim nonresponsive. He used a two-way radio to alert other co-workers, then went to a phone to call for EMS services. First responders were on the scene within four minutes. The coroner was called, and pronounced the victim dead at the scene.

Recommendation #1: Farmers who use skid steer loaders should always keep the seat belt fastened and the restraint bar in place when operating the skid steer loader.

Discussion: The seat belt protects the operator in several ways. The seat belt can protect the operator from being jostled and thrown against cab structures, or into the operating zone of the lift arms and bucket. During rollovers, the seat belt maintains the operator within the protective envelope of the If seat belts are part of the interlocked control system, they protect workers from being caught and crushed between the lift arms and frame.
